LOWER HOUSATONIC RIVER BASIN
SEYMOUR, CONNECTICUT

GREAT HILL RESERVOIR DAM
CT 00087

PHASE I INSPECTION REPORT
NATIONAL DAM INSPECTION PROGRAM

AUGUST 1978

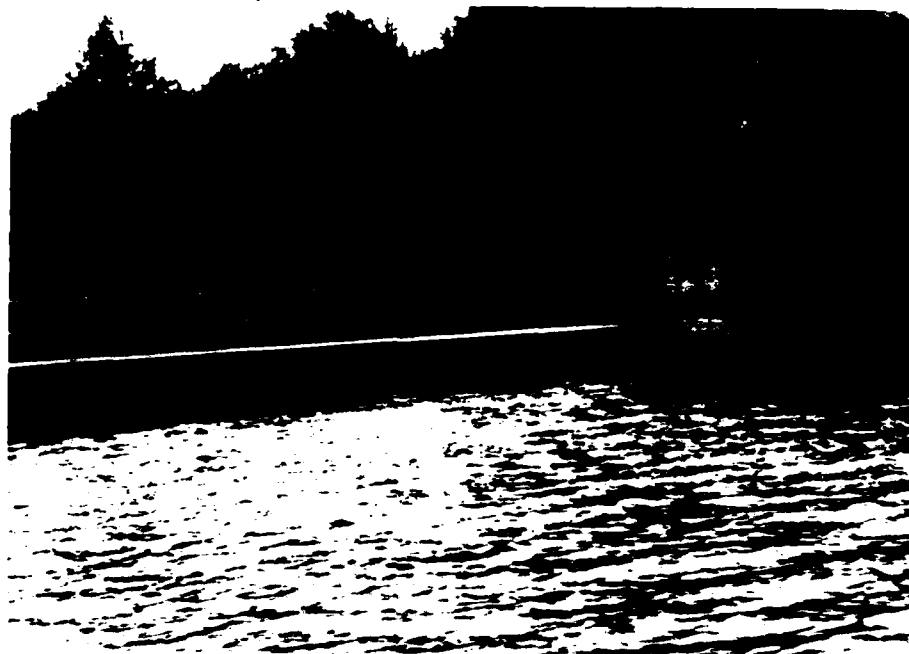
a. General - The appearance of the dam is generally good, except for spalling of the parged concrete face.

PHOTO NO.1 - Spalling at upstream face of left abutment.

1. Repair of spalled areas along entire length of dam including the crest and up and downstream faces; while establishing a regular maintenance program to resurface reoccurring spalled areas of the dam.
2. Inspection of the dam at least once every 2 years by an inspector qualified in dam inspection.
3. Opening of the low level outlet valve twice a year for a minimum of 6 hours. This would assure that it is operable and that the inlet doesn't clog with sediment.
4. Round the clock surveillance should be provided by the owner during periods of unusually heavy precipitation. The owner should develop a formal system with local officials for warning downstream residents in case of an emergency.
